Battersea Power Station

Review of the listed building consent application for the demolition and rebuilding of the four chimneys

23 September 2005

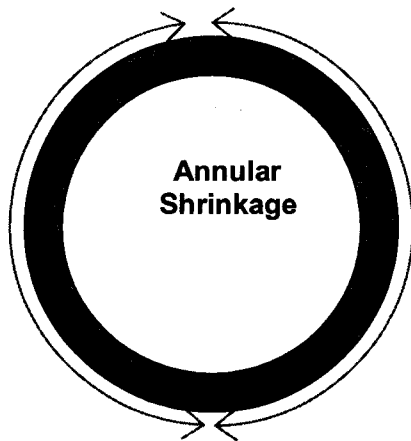
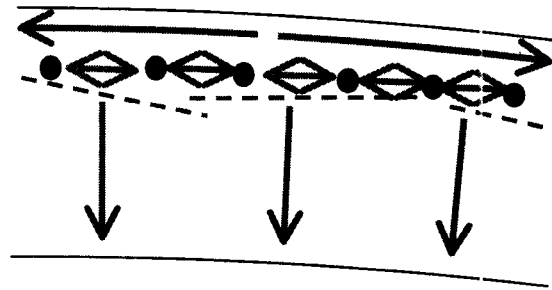
Concrete Shrinkage and Failure Planes

At the most simplistic level, if the delamination, had been the result of corrosion it would have occurred on the outside face of the reinforcement and the spalling would have been outward, with the expansive force reacting against the inner concrete, with sheets of concrete falling off. There is almost no outward spalling concrete apart from at high level where the chimney reduces in thickness. Our view is that the delamination and the cracking is almost certainly due to early age shrinkage of the concrete and has therefore been present in the concrete since construction

Normal shrinkage of concrete of this type would be of the order 5 parts in 10^4 to 1 part in 10^3 in the first year (IBIS: water/cement ratio is normal to above normal). This corresponds at the base to a linear shrinkage of 15-30mm, or a reduction in diameter of 5 -10mm around the circumference.

The annulus however means the shrinkage is unrelieved, causes the shrinkage to appear as compression on the helical steel, which is well designed to resist this. Linear, vertical shrinkage cracks in the concrete cover to the outer reinforcement will be the inevitable result. These cracks have been recorded on elevation drawings, albeit with the cracks shown at a much larger scale than is actually the case. The core concrete beyond the outer reinforcement is however unrestrained and the annulus diameter reduces, generating a stress field between the restrained outer and the unrestrained inner, with significant shear developing parallel to the external face.

The cracking and delamination is thus general, but is not ongoing.

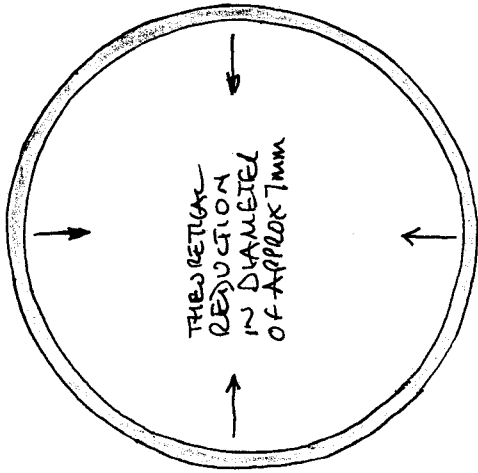
DRYING SHRINKAGE

The causes of cracks are not discussed, and so there can be no understanding of whether they are historic or ongoing, or structurally significant. One possible cause is from differential drying shrinkage between the outside and inside faces within the zone of unreinforced concrete. Without this understanding it is not possible to assess whether the cracks are historic or ongoing or whether they are structurally significant.

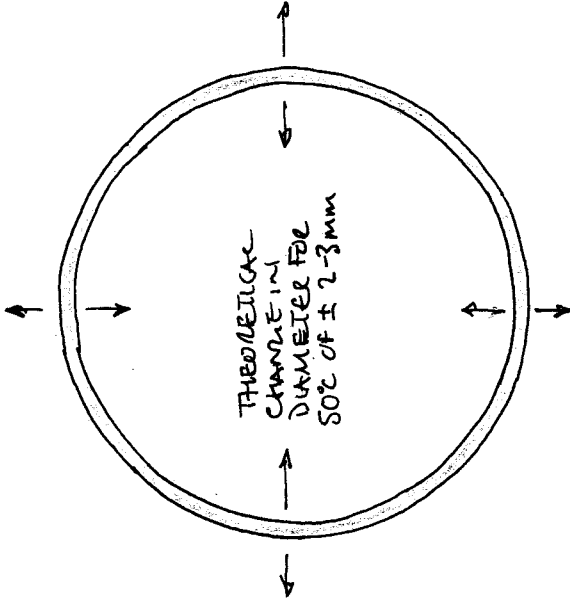
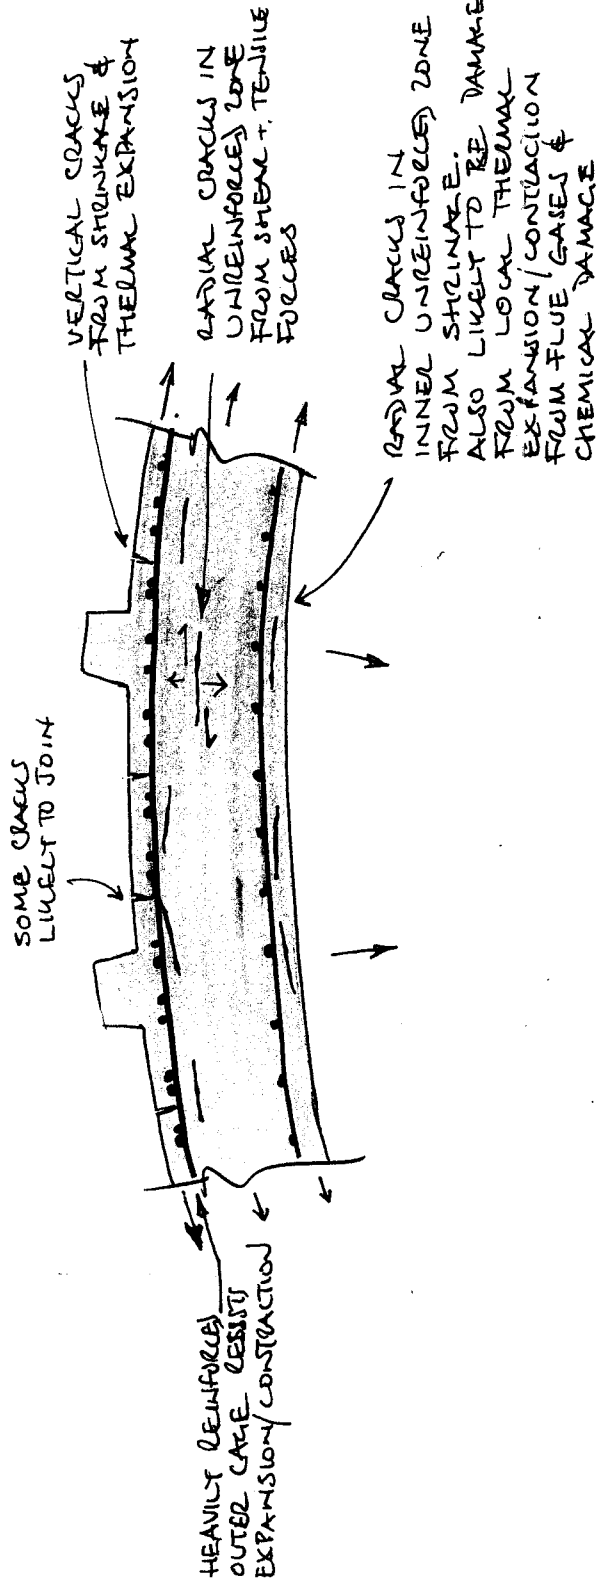
THERMAL EXPANSION + CONTRACTION

While there is a great deal in the report about the problems due to the concrete there is no structural analysis of the chimneys and the defects. For example how many of the cracks date from the original construction? The horizontal cracks are at regular centres and may be at construction joints. Similarly, many of the vertical cracks on the outside face are probably from drying shrinkage of the wet concrete (we have seen nothing on how the concrete was protected while it cured, nor any consideration of the importance of this). Other vertical cracks are likely to be due to thermal expansion and contraction of the chimney. We would expect to see some assessment of what changes in circumference would result a temperature variations.
